# Building Impact Analysis – 2012/13 Fire Season

**SIMON HEEMSTRA**

NSW Rural Fire Service

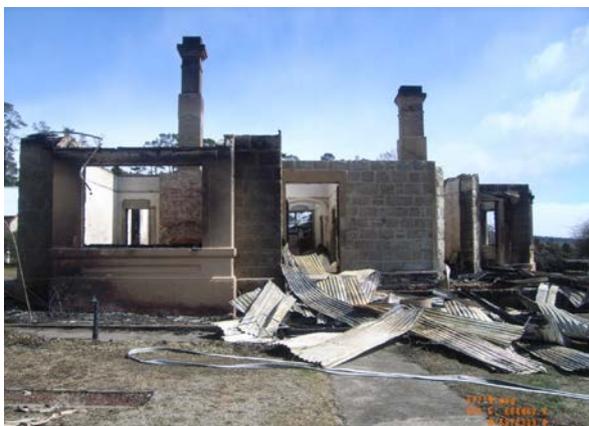
At the Dorian fire (Fig. 2), 1 house was lost. This house was built in the 1920s, with very old construction standards.

Fig. 2: 5<sup>th</sup> September 2012 – Dorian fire: 1 house lost, 2 untouched

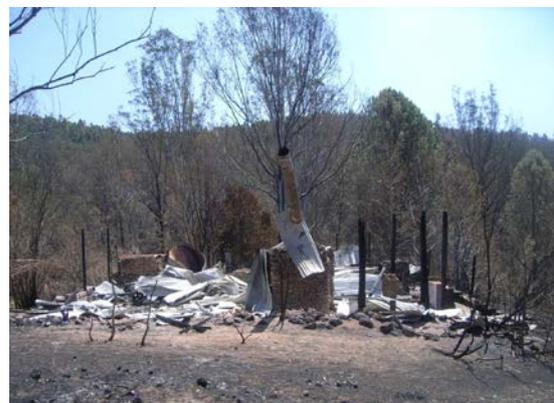
Also examined were structures at the Old Gibson Plantation fire (Fig.3), where the houses lost were holiday residences with dwellings unoccupied at the time. Only one of the damaged properties was used as a permanent residence.

Fig. 3: 20<sup>th</sup> October 2012 – Old Gibson Plantation fire: 3 houses lost, 2 damaged.

The three destroyed houses had rough sawn timber as the predominant external wall material. The lightly damaged house had stone walls with some rough sawn timbers and corrugated iron panels. The superficially damaged house had painted weatherboard external walls.

It appeared that most houses did not have ember protection on doors and windows. There was no underfloor protection on the house that sustained superficial damage.

Most of the surveyed properties appeared to have poorly maintained areas around the houses, with trees overhanging houses and continuous elevated fuels within 50m of the houses.

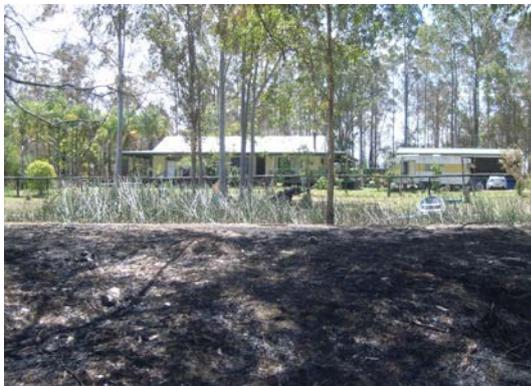
Conversely at Gungully (Fig. 4), there were no houses lost as they had been very well maintained.

Fig. 4: 20<sup>th</sup> October 2012 – Gungully fire: 6 houses untouched by the fire.

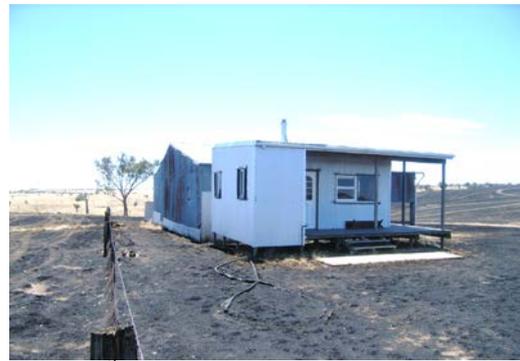
The BIA teams strive to collect equal amounts of information on the structures that were lost as well as the structures that survived, so that we are able to compare and learn from them. For example, in the Geegullalong fire (Fig. 5), one house survived because it had a fire hose in the front of the house. The fire burnt right up around and underneath the structure. Direct suppression and resident

action were quite important in saving the house.

Fig. 5: 12<sup>th</sup> December 2012 - Geegullalong fire: 3 houses untouched.
